Introduction

Investigation of Methodologies for Fiberglass Resin Removal from Bone Mellisa Thew, Anthropology

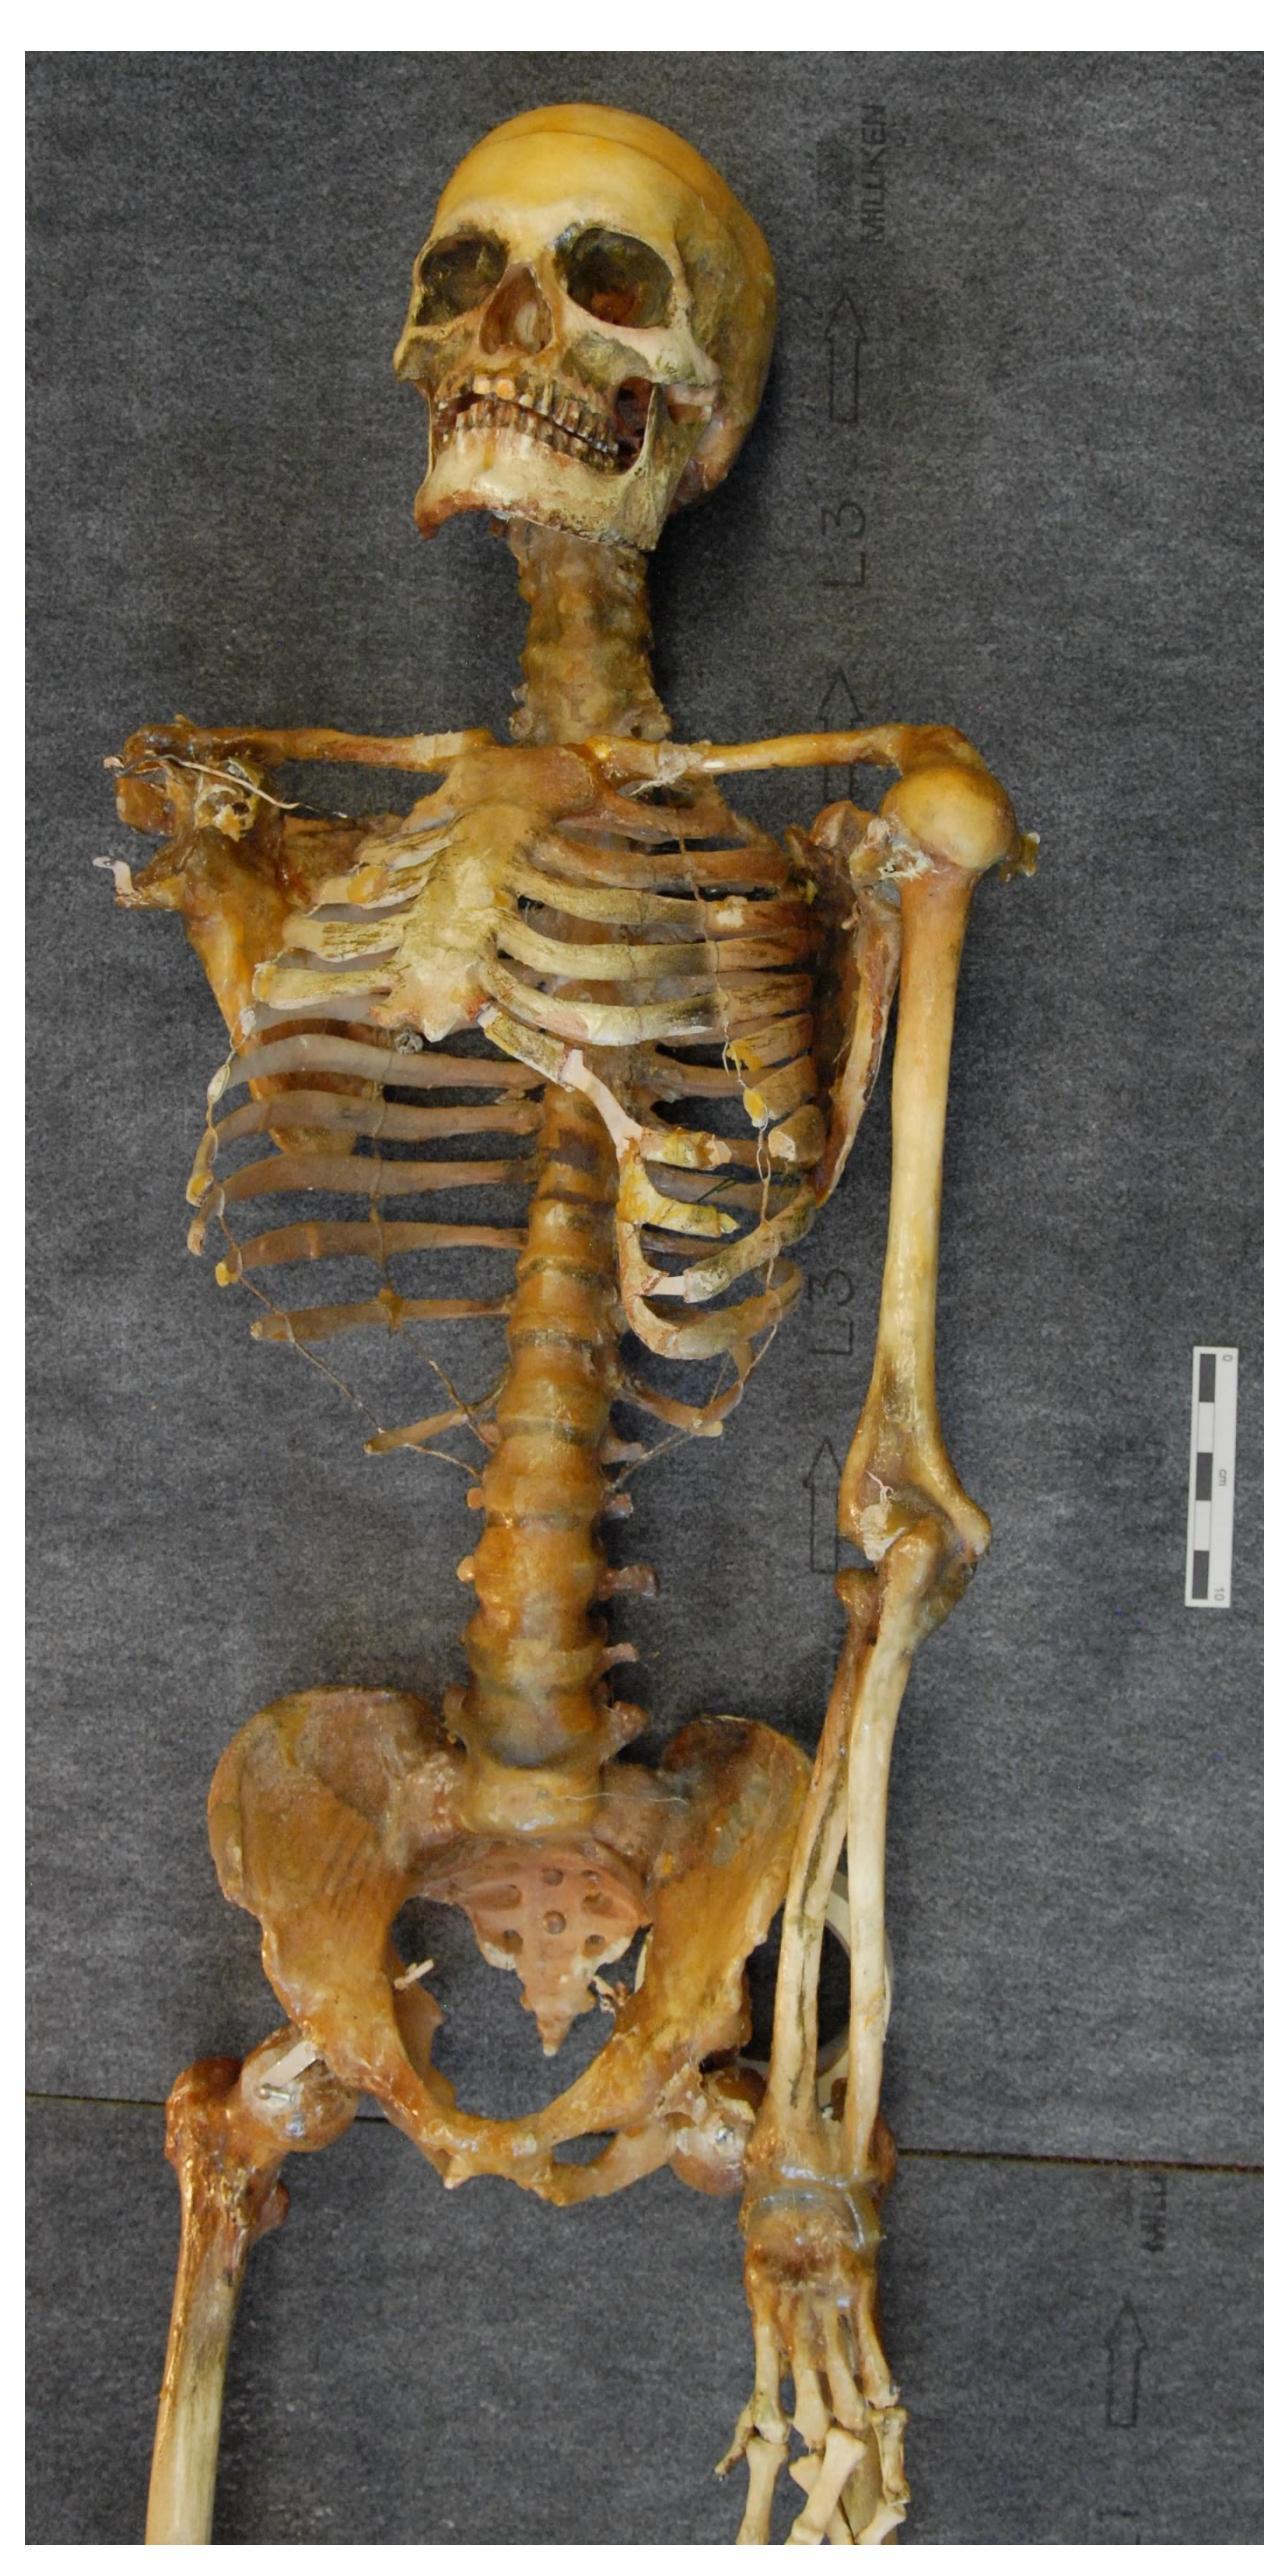
Figure 1: Fiberglass coated human skeletal remains

The fiberglass coating on the human remains left the joints rigid and the bones unsuitable for analysis. The bones were also held together by a wire frame.

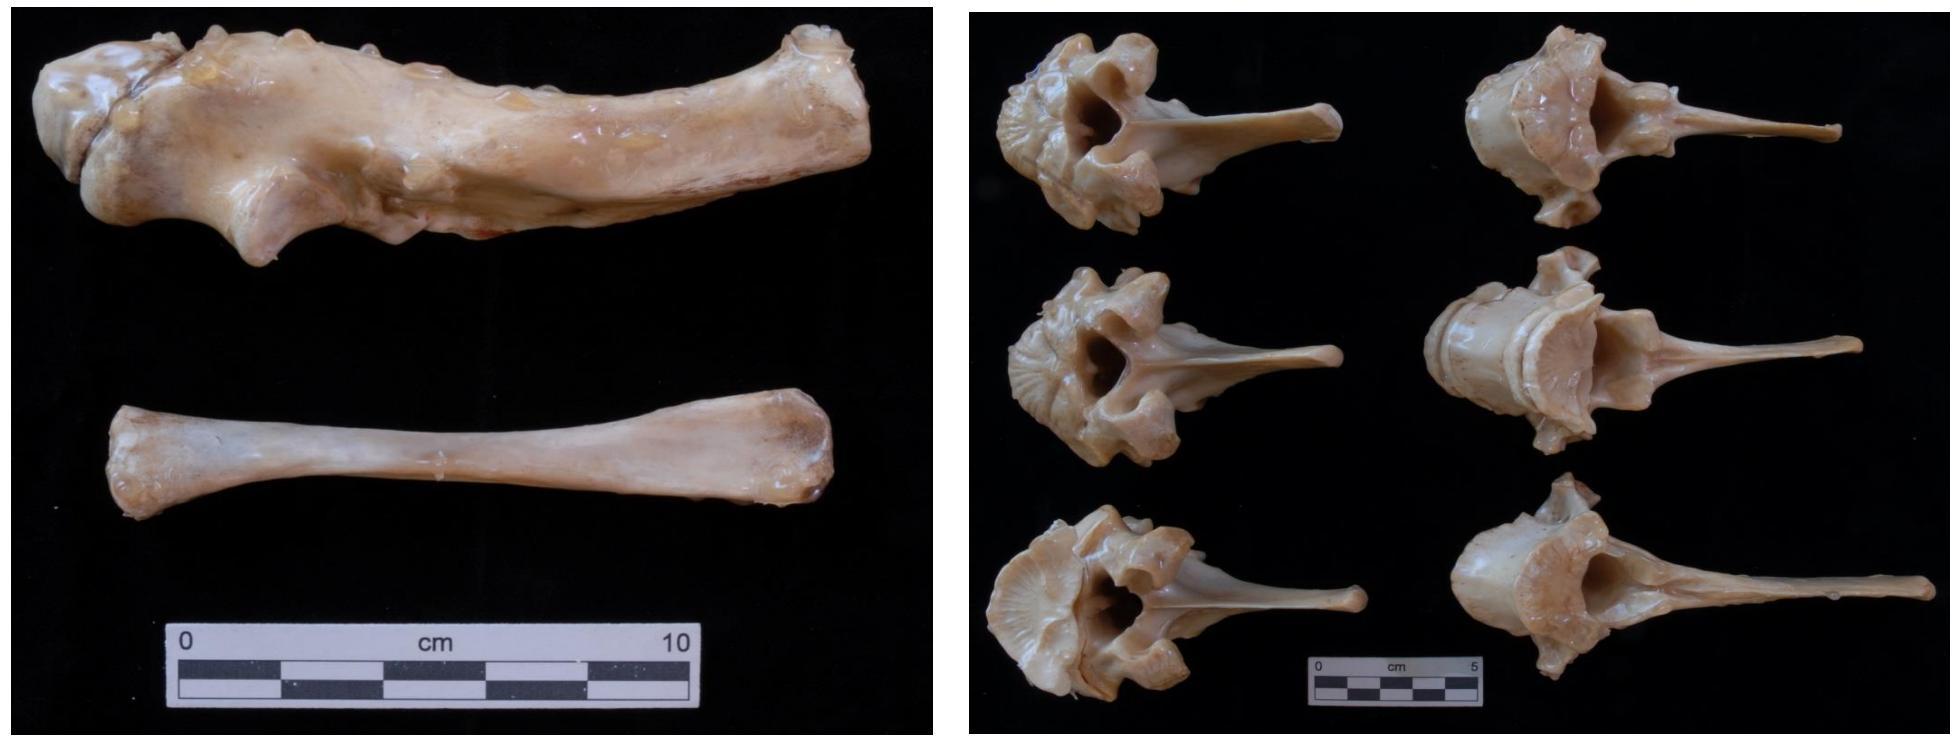
The bones used for the first stage of testing consisted of green (fresh) and dry pig bones to ensure that the most appropriate method could later be applied to the human remains. A combination of long bones, vertebrae, and ribs were coated in fiberglass resin and allowed to cure (See Figure 2). Two main methods of fiberglass removal were then tested: chemical solvents and application of heat.

Figure 2:Using bones from a butcher and the MacEwan zooarchaeology collection, Bondo© fiberglass resin was painted onto the bones and allowed to cure after two coats.

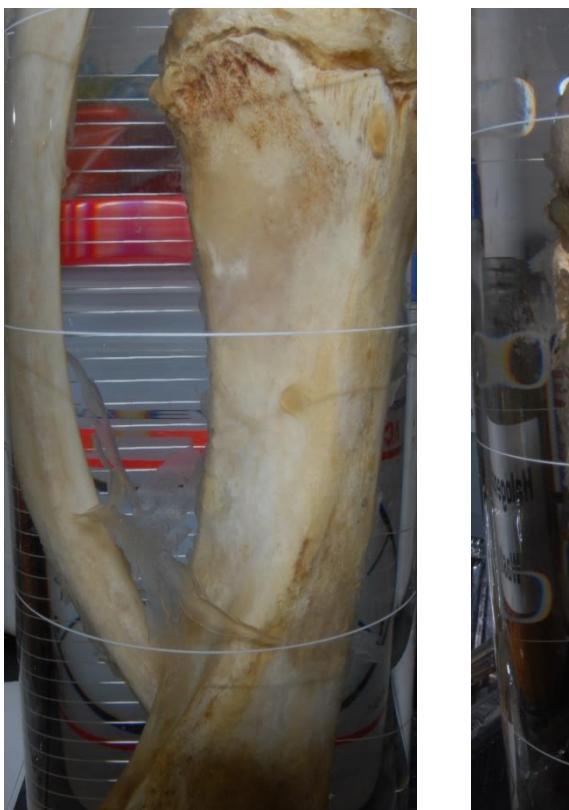
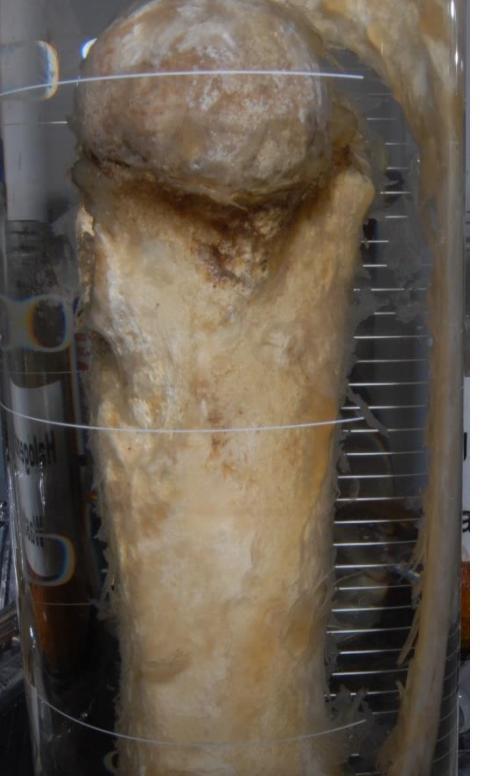
Solvent removal: was attempted, first, through small-scale brushing applications and second through total submersion of the bones (Figure 3; Table 1).

Figure 3: Ethyl Acetate (left) and Acetone (right) removal in process. The solvents reacted differently with the resin. This resulted in peeling with the ethyl acetate and flaking with the acetone.

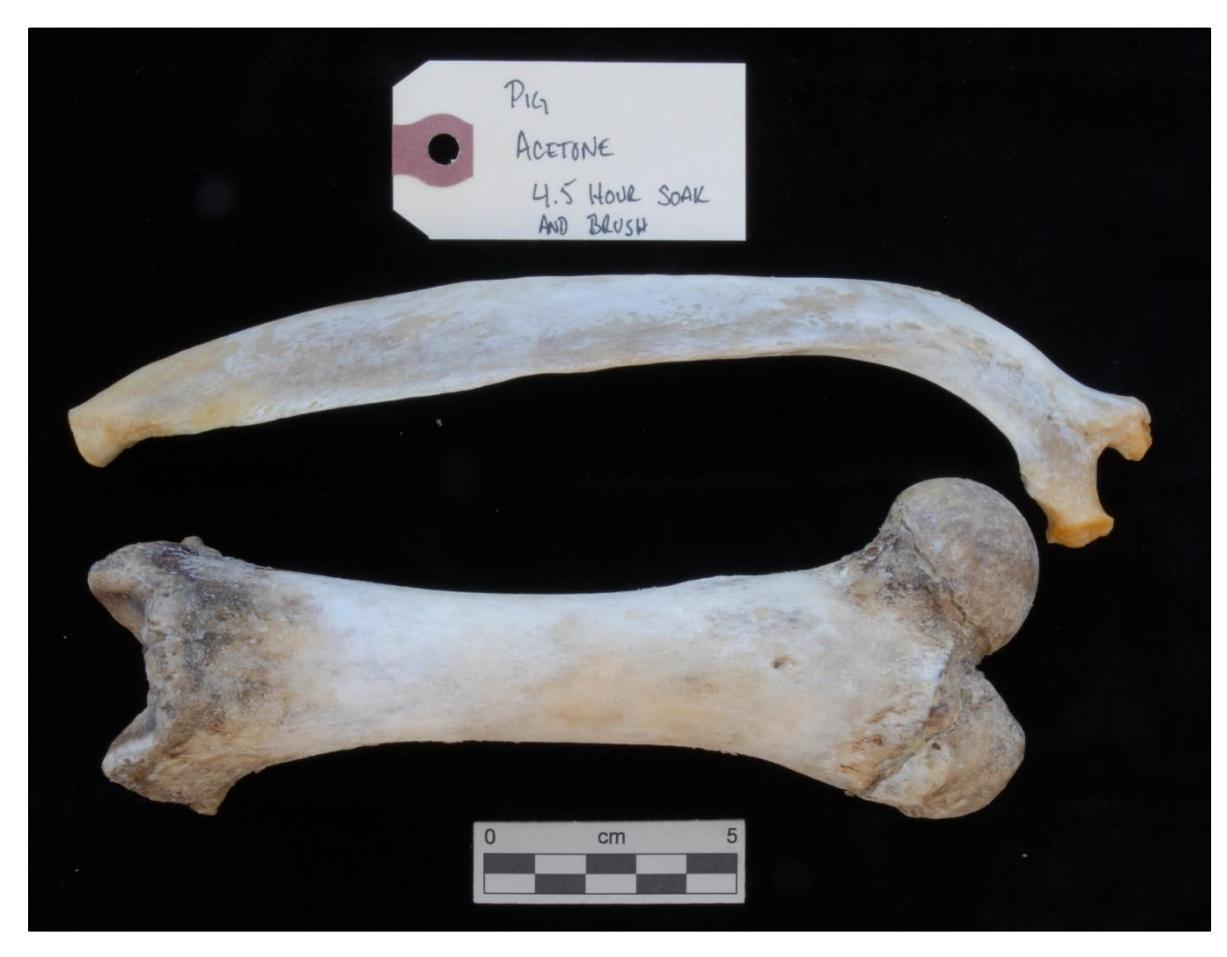
Figure 4: Acetone Removal

The acetone soak worked well, and with a little manual manipulation, the resistant resin was easy to remove. However, both the green and dry bone developed a greasy feel.

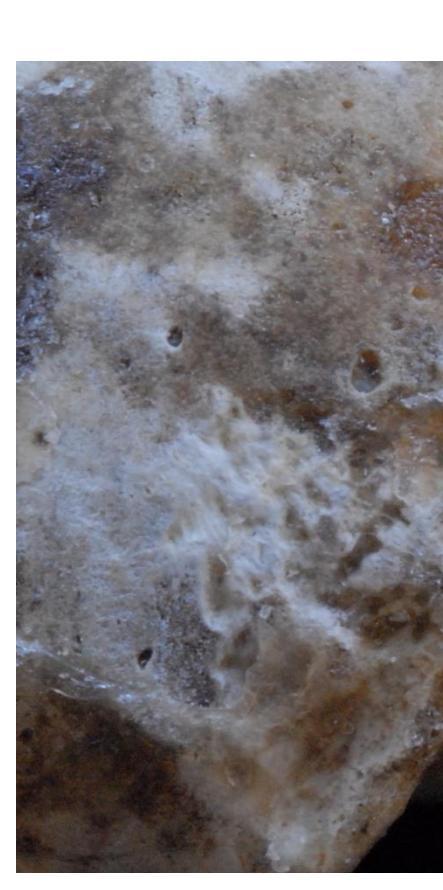
<u>Heat testing</u>: was performed with a heat gun and scalpel to remove the loosened resin; a digital thermometer was used to monitor the heat ranges.

Figure 7: Heat Removal

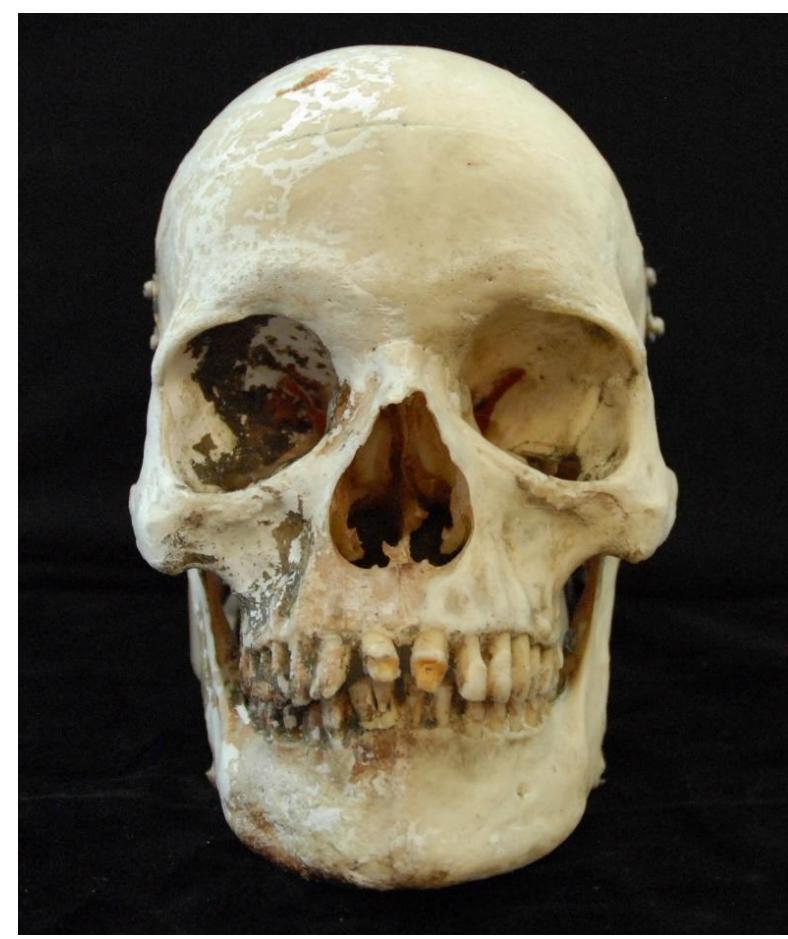
Figure 9: Skull half cleaned of paint

Final Cleaning Stages Following resin removal, it was discovered that many bones had also been painted. So, the remains were cleaned with acetone to remove the paint and additional adhesive

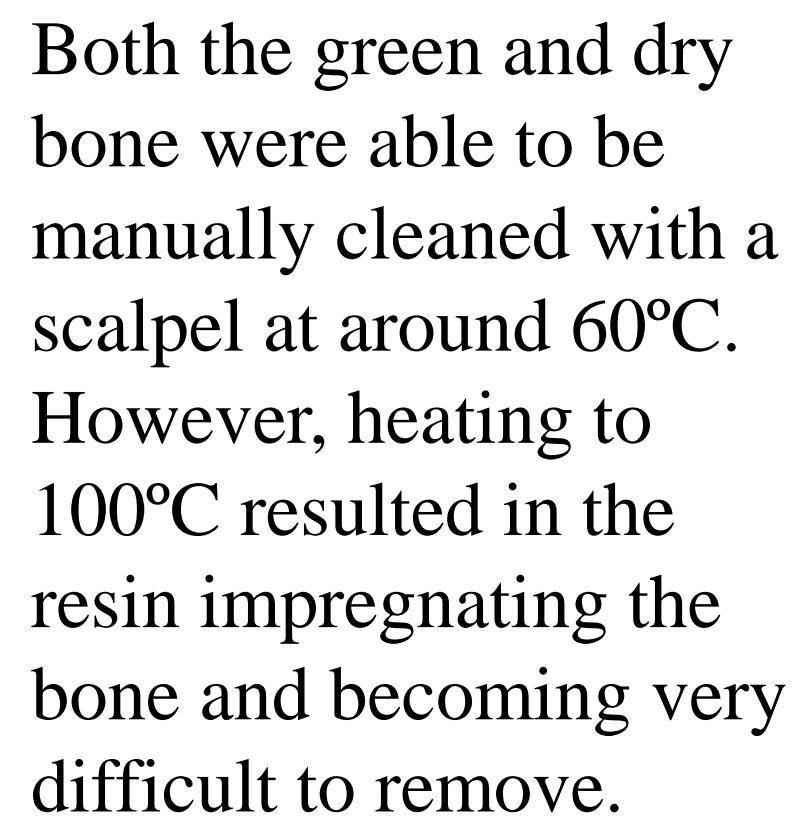
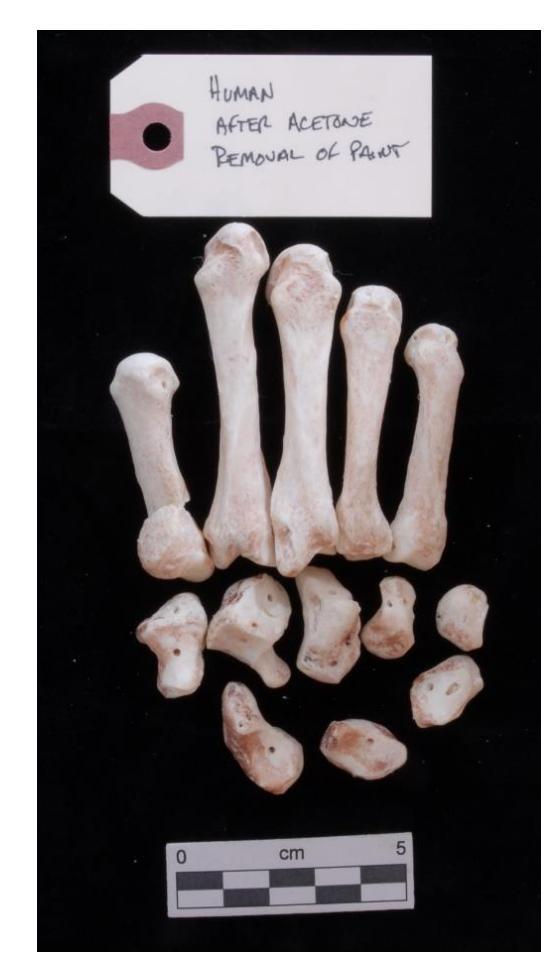
Figure 10: Completed cleaning

After removal from the metal frame, the remains are now fully disarticulated and ready for inclusion in anthropology teaching collections.
